Thompsonville Fire Department

**Thompsonville Fire Department
11 Pearl Street
Enfield, Connecticut 06082-3501
Phone: 860-745-3365 Fax - 860-745-1492
Connecticut State Fire Safety Code
Abatement Order of Fire/Life Safety Hazards**

Thompsonville Fire Department The Site

Thompsonville Fire Department The Facility

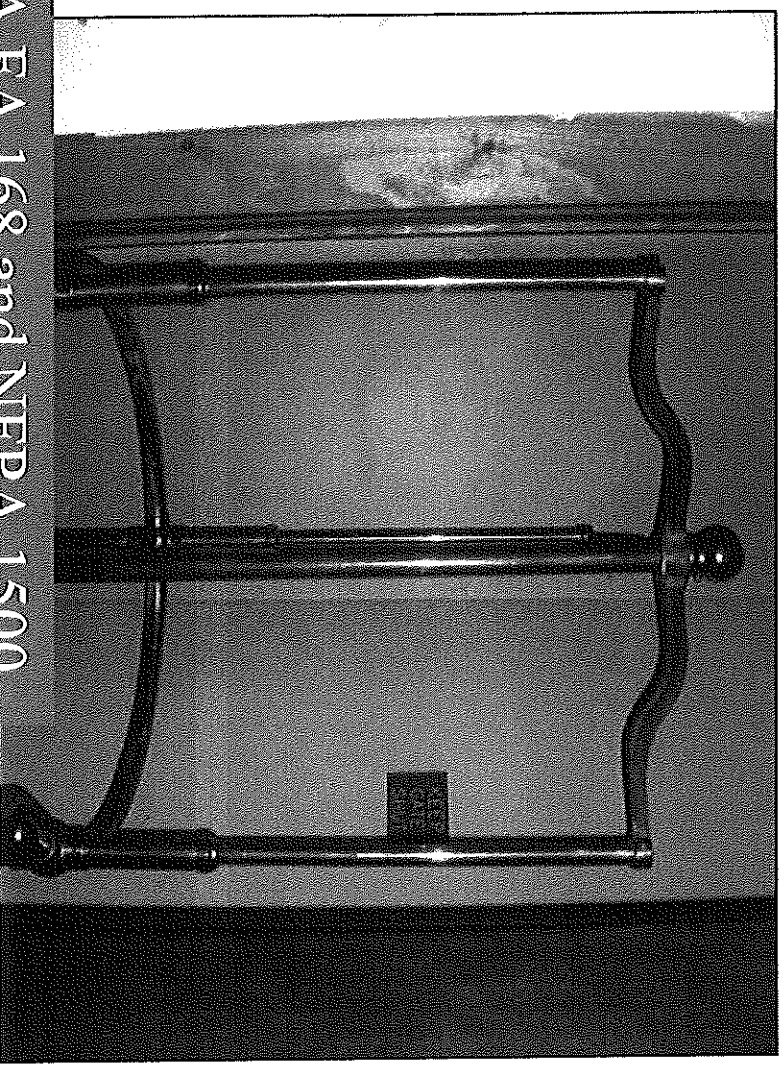
Despite walls built
around pole, exhaust
enters sleeping areas.

Non-conformance with FEMA FA 168 and NFPA 1500

- Prevent contamination of living and sleeping areas by vehicle exhaust and noise
- Separate living and sleeping areas from apparatus bays

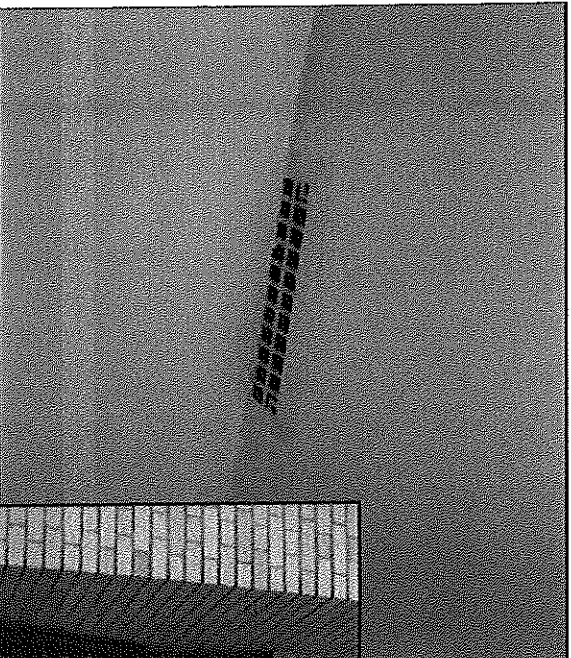
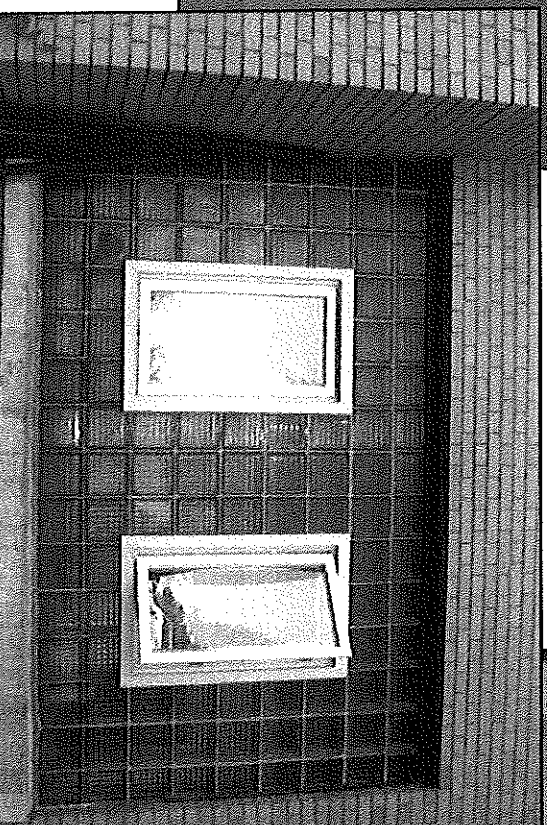
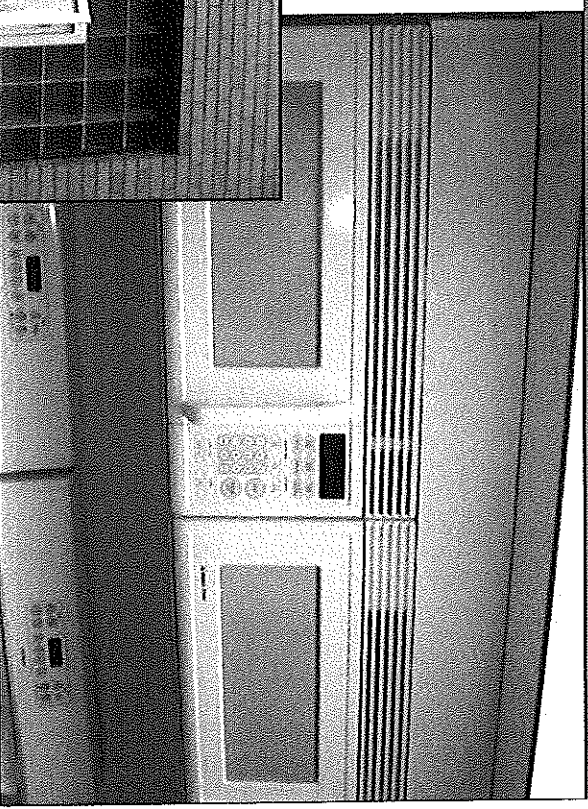
Inadequate and limited ventilation

Non-conformance with FEMA FA-168

- Positive pressure in living and work areas to prevent vehicle exhaust from entering

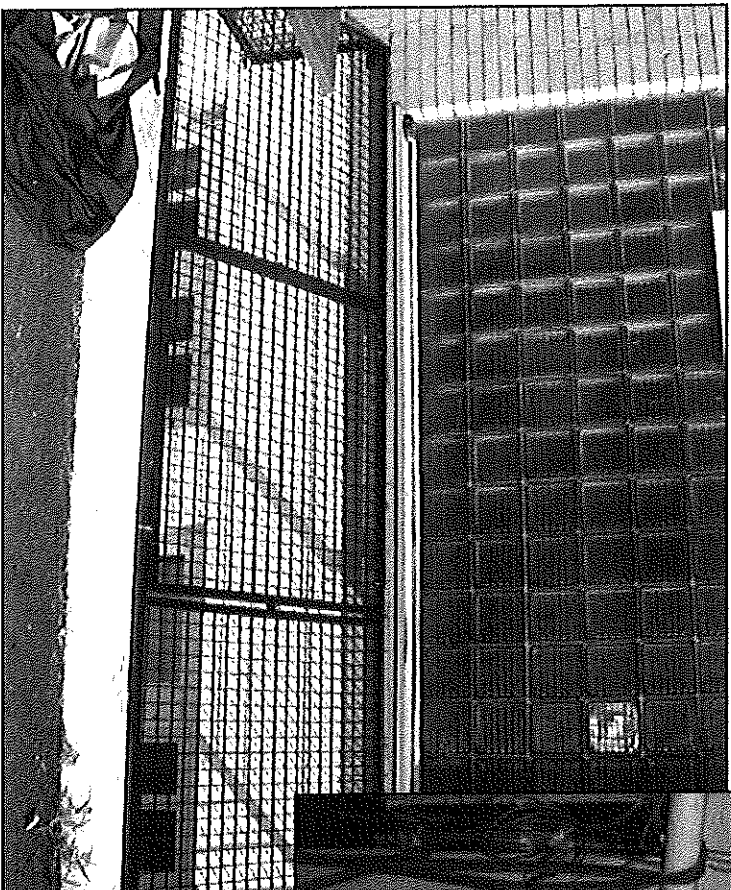
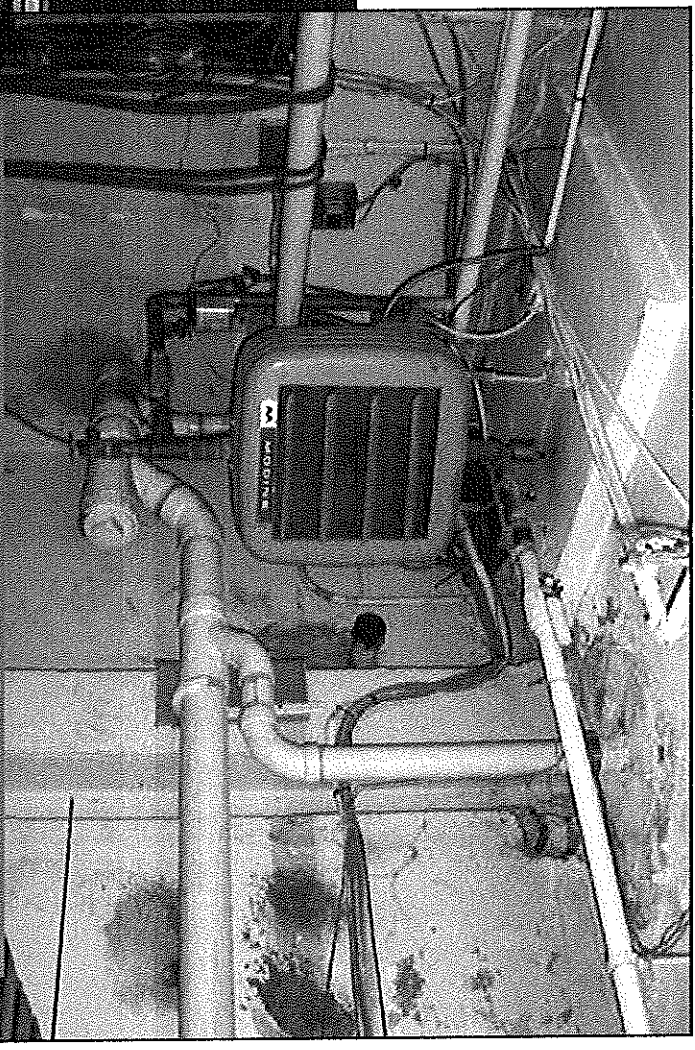
Minimal heating and
ventilation

Non-conformance with FEMA

FA-168 and NFPA

- Operational standards for mechanical ventilation

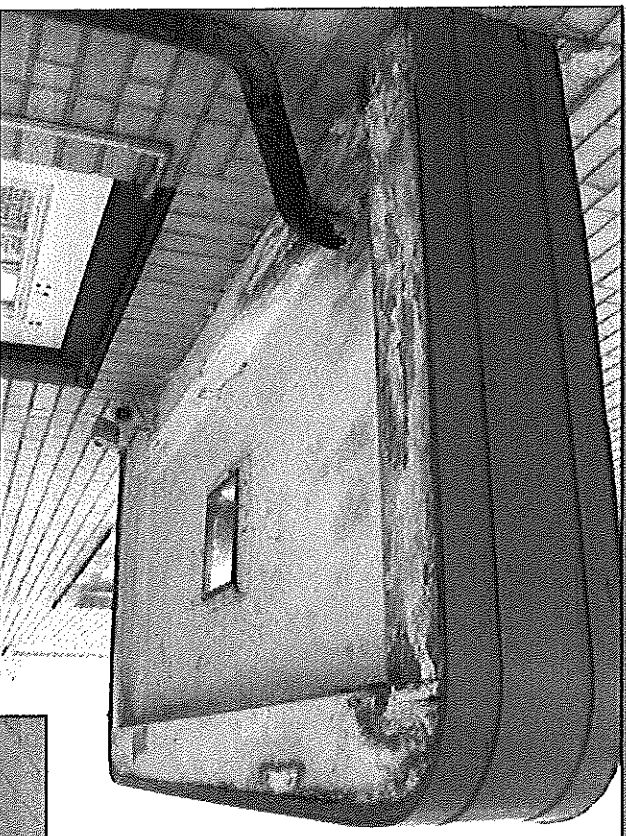
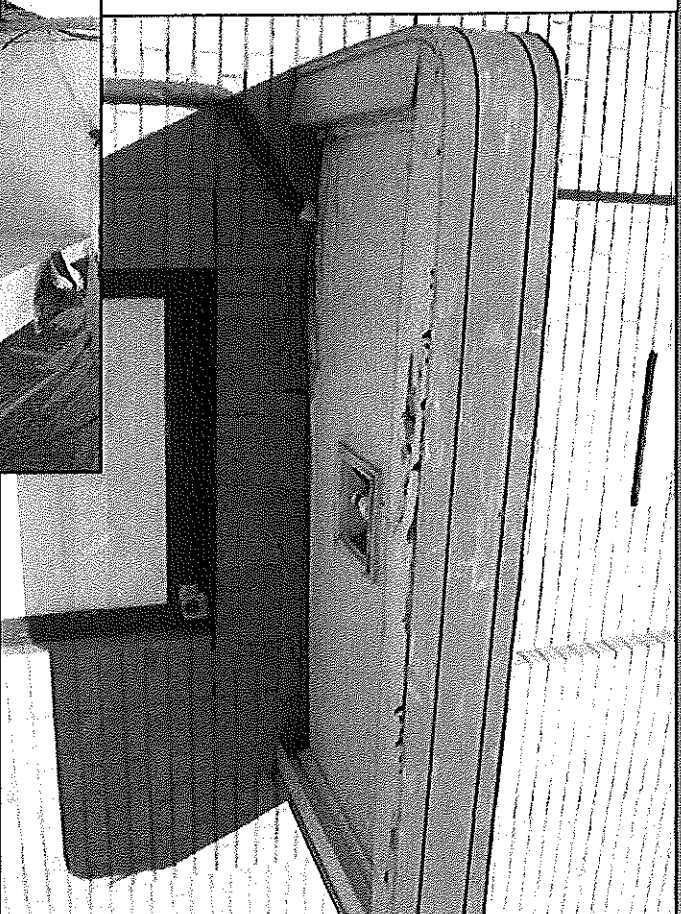
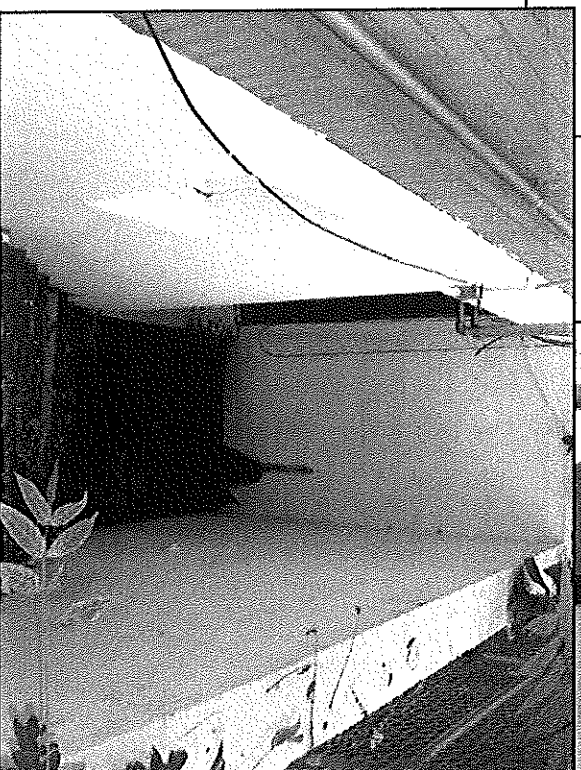
Exterior water damage
